# LAKE SIR-JOHN

## AQUATIC PLANT SURVEY - 2025

**DATE:** July 28<sup>nd</sup>, 2025

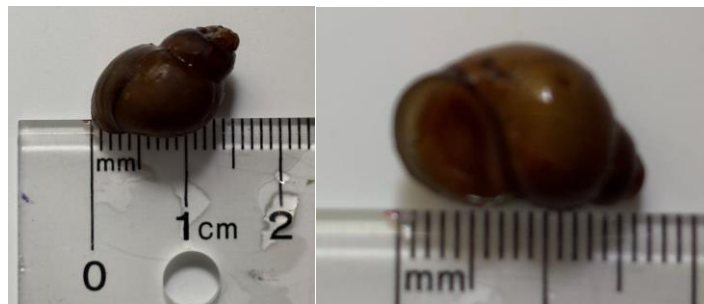
2 very small snails were found on the shoreline of Lake Sir-John – since the survey, more small snails have been found – presumed indigenous since no larger snails have been discovered.
